CONSERVATION OF THE WALL PAINTINGS IN THE MEMORIAL CHAPEL LIBRARY AT QUEENS COLLEGE, CAMBRIDGE

Report No: QCC01/02 **Date:** 20th August 2017

Conservation of the Wall Paintings in the Memorial Chapel Library

Queens' College, Cambridge

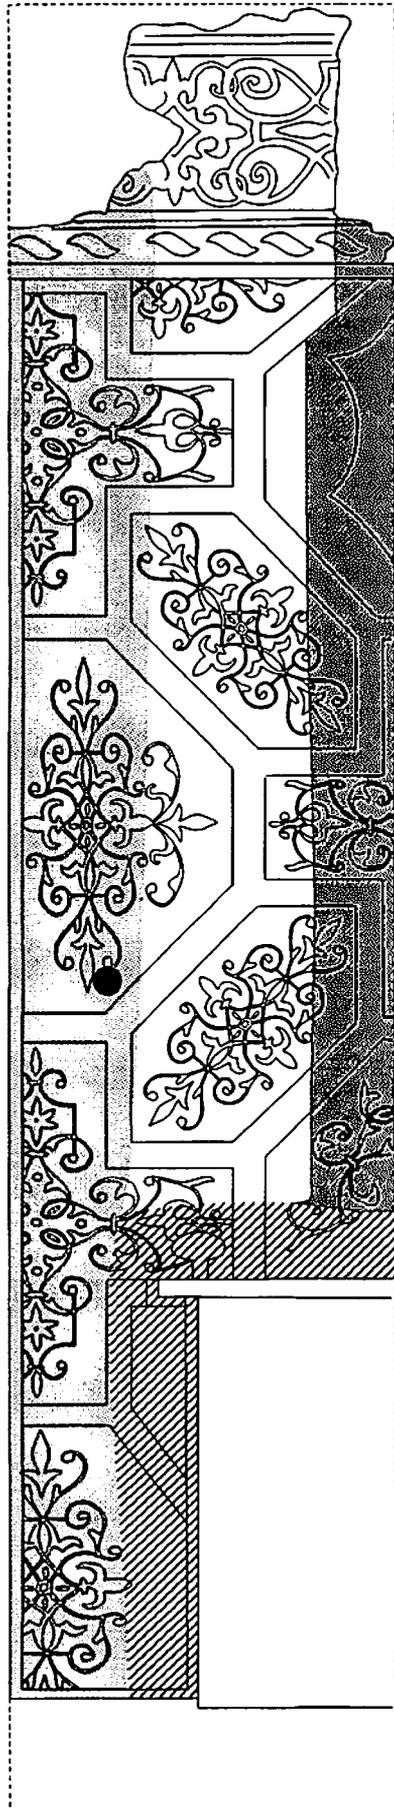
Diagram 3. Elevation of the south wall showing the surface condition of the wall painting before conservation

Despite certain types of deterioration which had effected the painting as a whole, the surface condition varied considerably. (*Diagram 3*) On the left hand side of the body of the painting the main problem was one of delamination between the paint layers and the limewash ground. Actual paint loss was comparatively limited, however much of the adhesion between the layers had failed, and the resulting flakes of paint were extremely vulnerable to accidental mechanical damage. Where losses had occurred, these extended only to the lime ground and not to the substrate. (*Plates 5 & 6*)

On the right hand side of the painting, the loss was more extensive, but in this area there was a loss of cohesion in the paint layers and areas of extremely small and powdering flakes of paint. The nature of this damage and its concentration in a clear vertical line suggested that the area had been sealed in by the inserted wall, and the resulting microclimate had caused considerable deterioration of the paint layer and in particular, the medium.^{11 & 12}

Areas of particularly serious delamination between the paint layers and the lime ground

Serious Loss of cohesion and micro flaking, apparently as a result of the micro climate caused by the close insertion of a partition wall

Areas of loss of pigment cohesion associated with the different layer of plaster surrounding the cupboard

Drill hole, which appears to have been used to support the earlier paneling

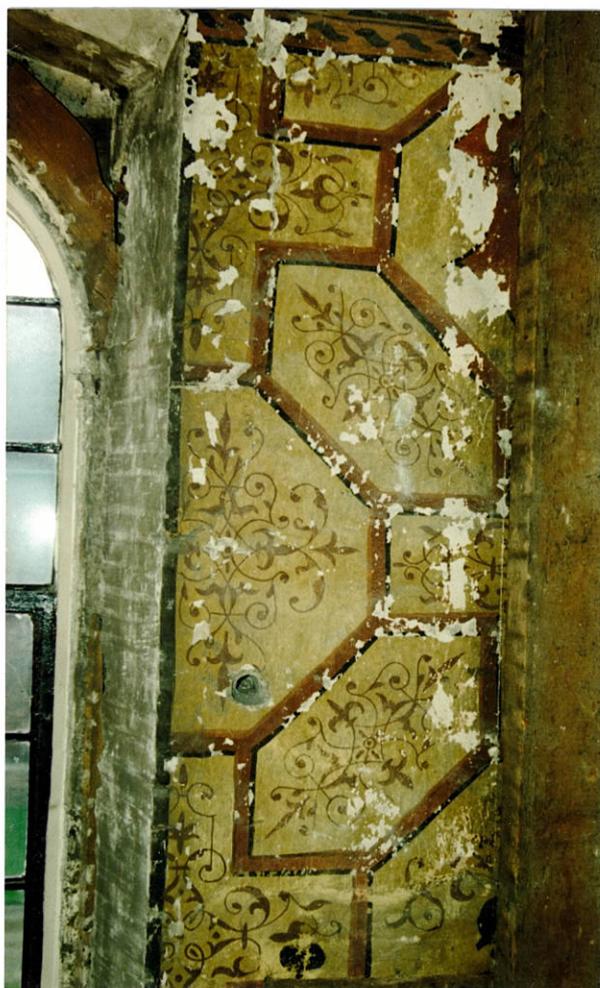
Plate 1. (Above) General view of the central area of the painting before conservation. The vertical line of loss on the right hand side appears to be due to the very close insertion of an earlier wall and the resulting build up of a damaging micro climate. The post on the right hand side is part of the 19th century partition. (Photo: Tobit Curteis 1994)

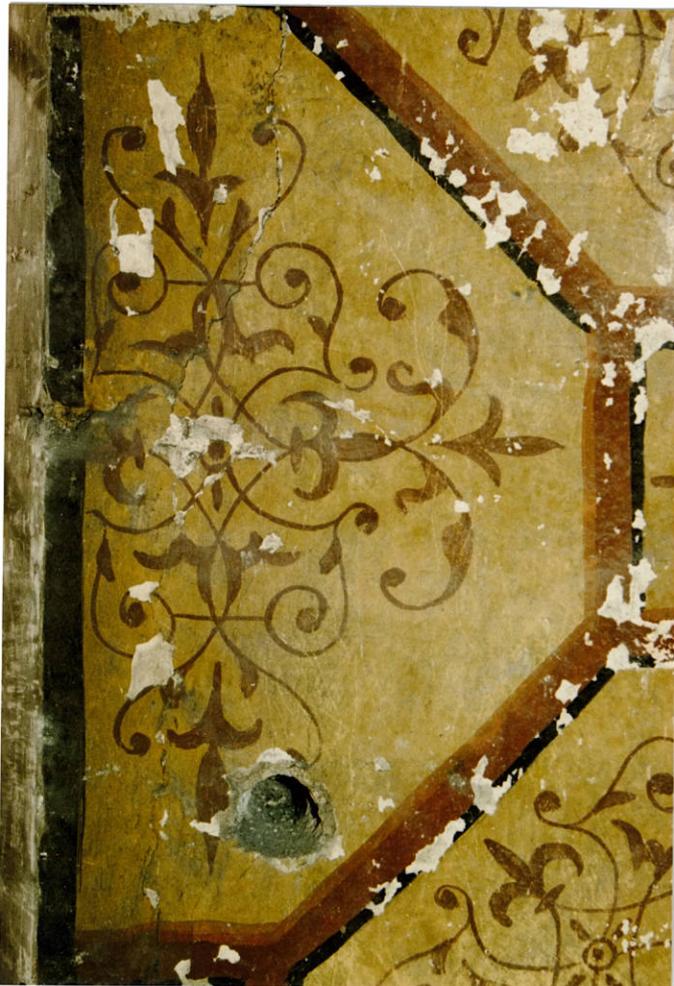
Plate 5. (Below left) Detail of the central area of Plate 1 showing the most complete of the arabesque designs. Despite its regularity, the painting has been carried out freehand, apparently without the use of an underdrawing. (Photo: Tobit Curteis 1994)

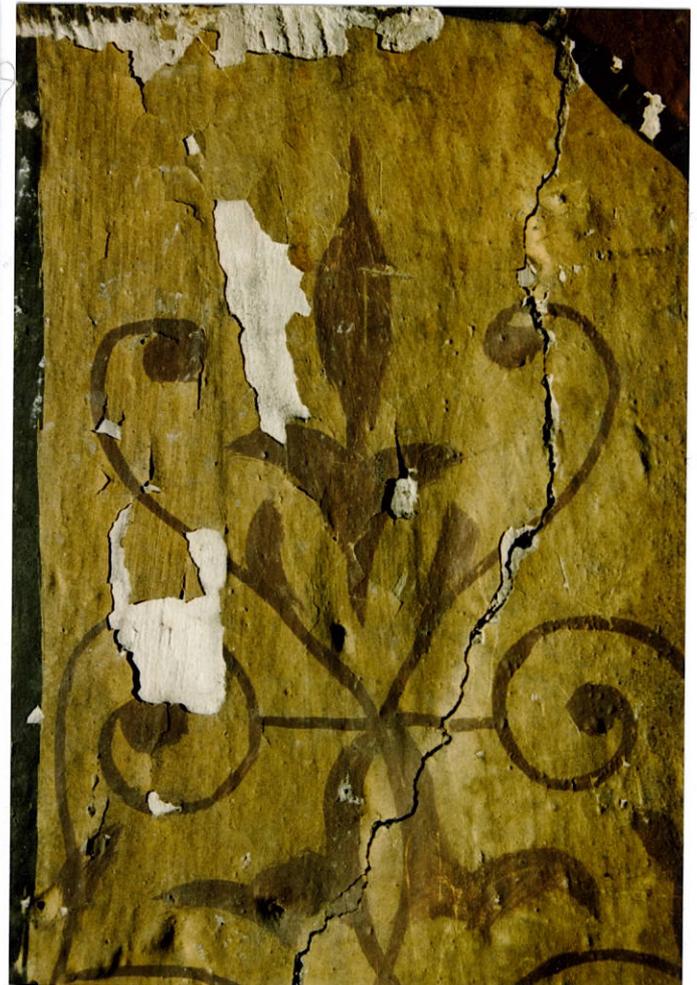
Plate 6. (Below right) Raking light detail of the upper left hand area of the previous plate showing the level of delamination and flaking of the paint layer. (Photo: Tobit Curteis 1994)

These flaking areas were first treated with an injection of IMS and water (50:50) in order to reduce the surface tension. A 10% solution of the acrylic emulsion Plextol B500¹³ was then injected behind the flakes, which were held in place while setting occurred. Any excess adhesive was removed using acetone. The entire painting was then covered with a layer of Japanese tissue attached at specific points using a solution of 10% Paraloid B72 in acetone. A polythene sheet was then attached over the tissue having first been cut with ventilation holes to prevent the build up of any moisture.

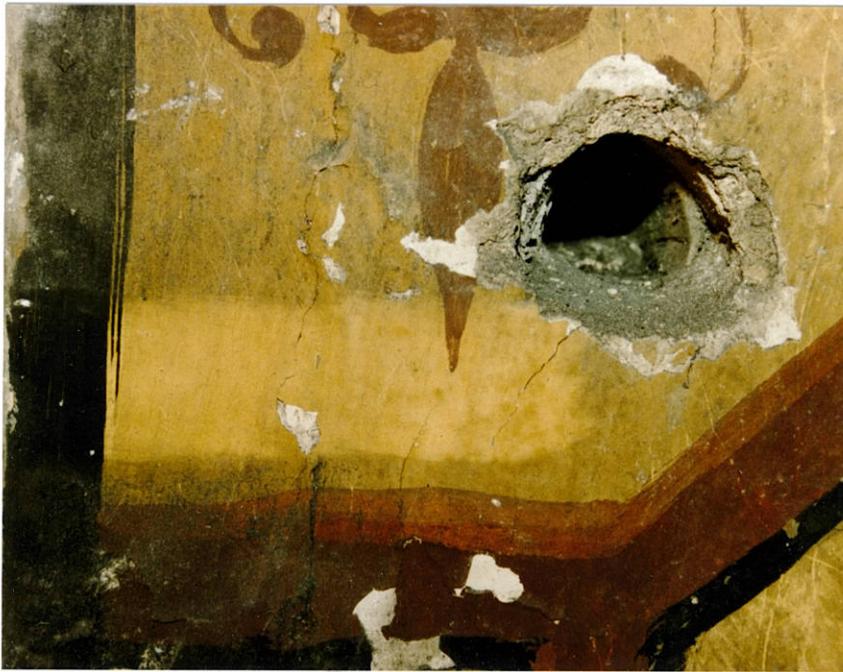
Plate 9. (Left) Detail of the central area of the painting during conservation, showing a cleaning test using a Wishab silicon sponge. The surface dirt was particularly dense in this area, but was easily removed with light mechanical action. (Photo: Tobit Curteis 1994)

After extensive tests, the use of Wishab silicon sponges was found to be the most effective and delicate method of removing the surface dirt. (*Plates 9 & 10*) In some areas it was found that Wishab also acted well on the stone. However, on the whole the stone surface responded better either to soft mechanical action from a India rubber or to swabbing with a saturated solution of ammonium carbonate and tri-ammonium citrate.¹⁶ On the splay of the window, the deteriorating and dirty limewash was removed using a small scalpel. Although relatively soft, the limestone was found to be in good condition, retaining much of its original tooling marks. The removal of the limewash also exposed two identical mason's marks of the following type:

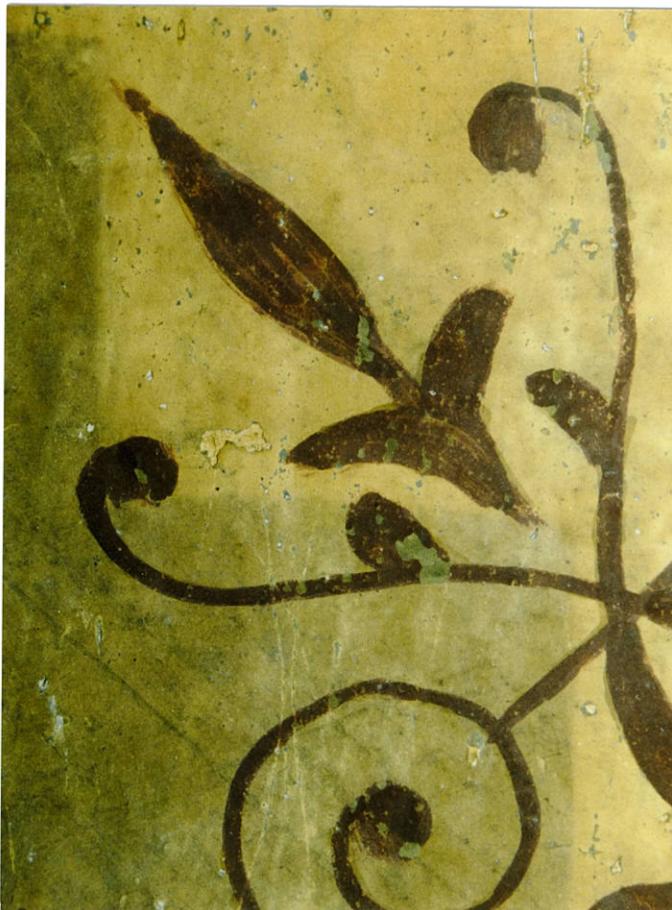
Plate 10. (Below left) Detail of one of the central arabesques during cleaning. The loss of the upper paint layer has clearly exposed the green ground layer in a number of areas. (Photo: Tobit Curteis 1994)

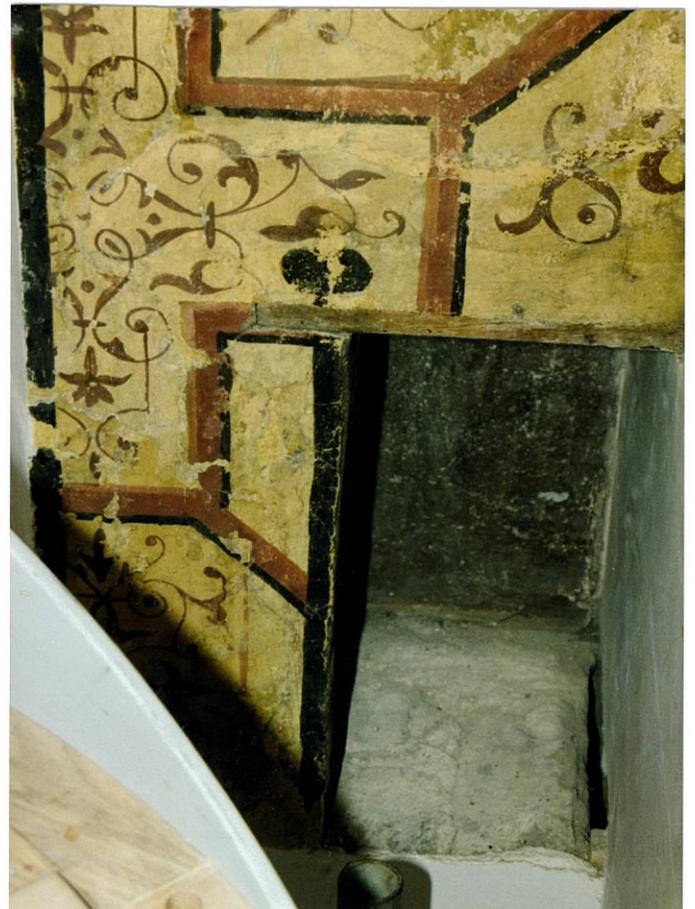
Plate 11. (Below right) Detail of the lower area of the painting after conservation. Despite the high level of damage in this area, the cleaning has exposed a great deal of the detail. The edge of the new staircase can be seen in the foreground of the plate. (Photo: Tobit Curteis 1994)

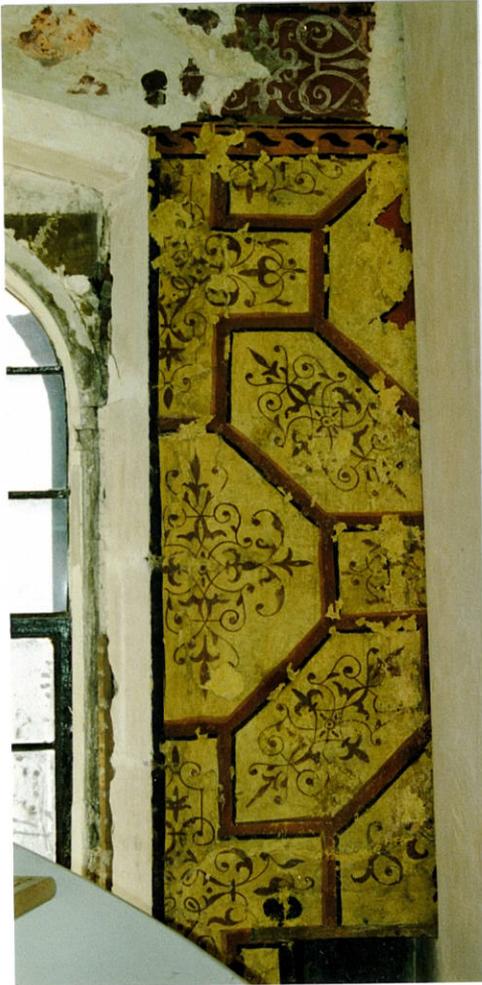
- **Plate 12.** (Above left) General view of the wall painting after conservation. Reintegration was limited to the use of toned watercolour washes used to reduce the aesthetic disruption caused by the surface loss and the bright white ground. The uncovering and cleaning of the stone, both over the lintel and within the splay of the window, considerably enhances the overall effect of the painting. (Photo: Tobit Curteis 1994)

Due both to the decorative nature of the painting and the strong pictorial lines, the need for reintegration was felt to be relatively limited. On areas where the paint loss exposed the bright white background, toned watercolour washes were used to reduce the aesthetic disruption.¹⁷ However, no reconstruction was carried out and the effect of the toned washes was to draw the painting together to such an extent that the disturbance caused by the damage was considerably reduced. (*Plates 11 - 14*)

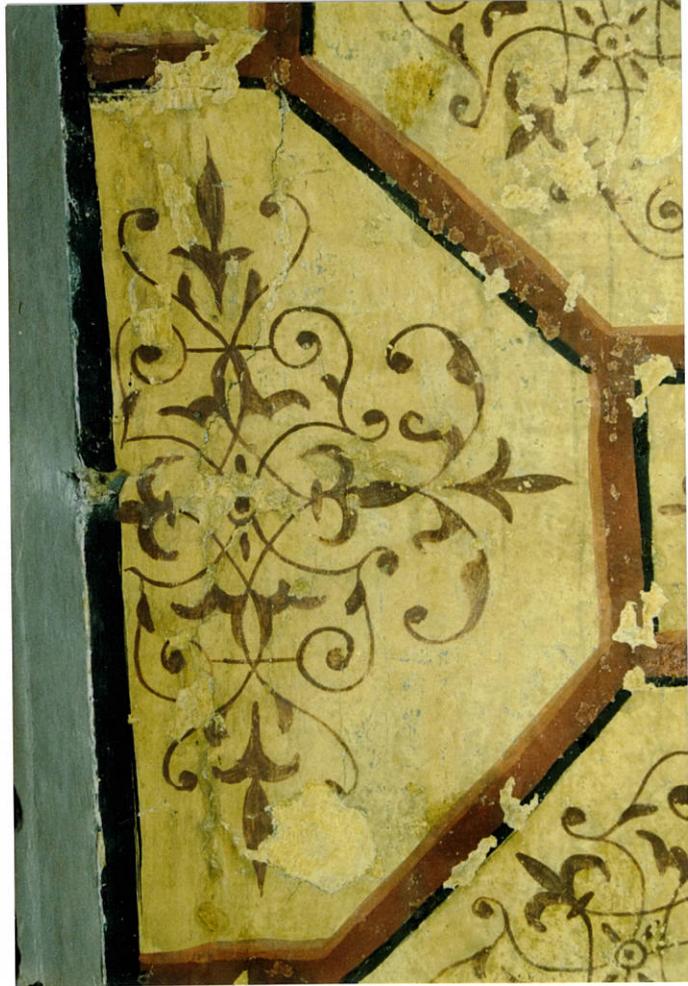
Plate 13. (Above right) Detail of the previous plate showing the central arabesque after conservation. Comparison with Plate 5 clearly shows the effect of the cleaning and reintegration that has taken place. (Photo: Tobit Curteis 1994)

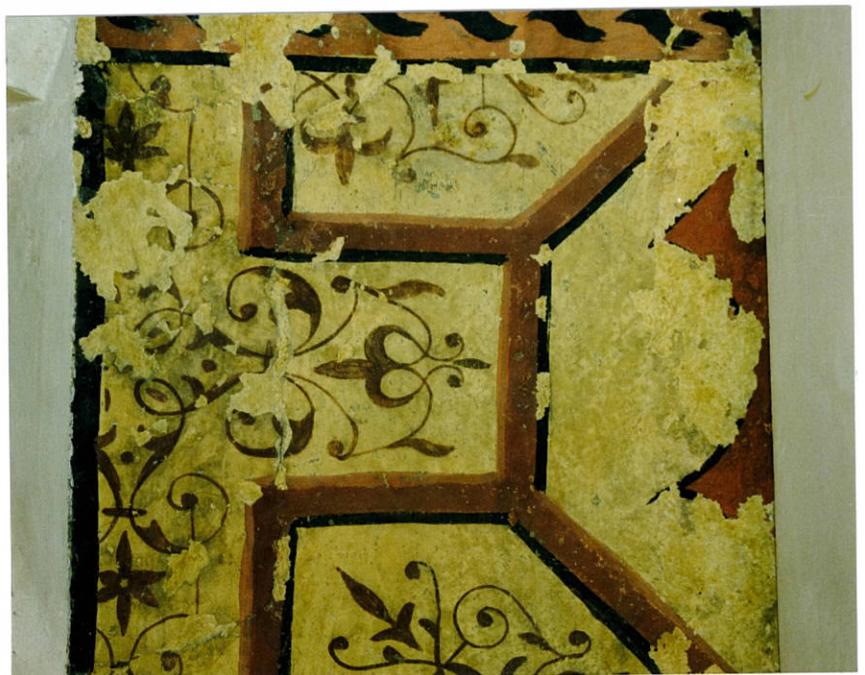
Plate 14. (Right) Detail of Plate 13 showing the upper part of the painting after conservation. The new wall on the right hand side has further obscured the coat of arms. (Photo: Tobit Curteis 1994)
