**Condition Assessment  
and Treatment Report for  
The Old Hall,  
Queens' College,  
Cambridge.**

**January-May 2005**

**Project:** Cleaning and restoration of the fireplace and polychrome decoration in the Old Hall, Queen's college, Cambridge.

**Nature of project:** Condition survey of the polychrome decoration on the ceiling and walls.

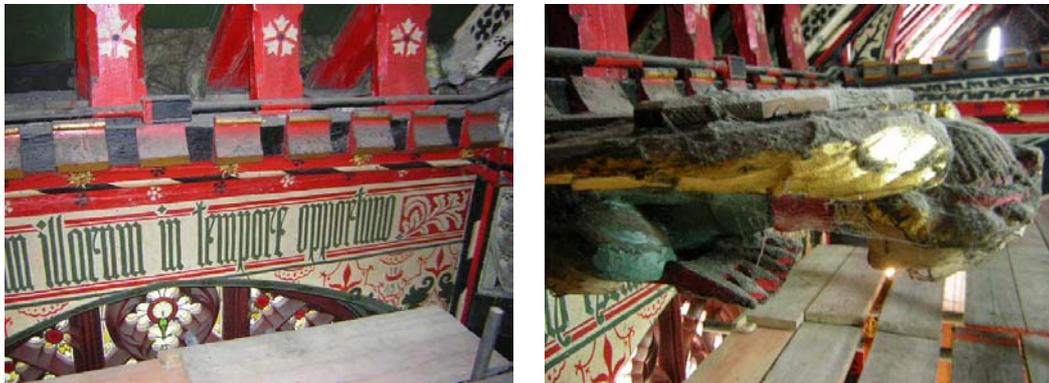
**Figures 1 and 1a:** Images of components of the ceiling prior to treatment. Note the high level of surface dirt.

paint film is discoloured through surface lying dirt, particularly pronounced on upward facing elements of design (see figures 1 and 1a). Accretions of nicotine, obvious as brown flecking, and yellow/brown run marks, are apparent on the lighter elements of the ceiling.

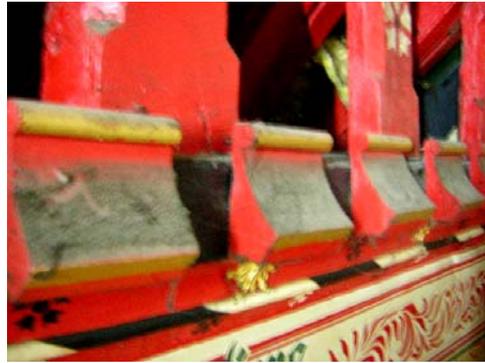
**Figure 2:** Image of the castellations before treatment

The wooden castellations, which run above the painted frieze, are decorated with red paint and gilded detail. The castellations are very dirty, with the upper slanted plane coated with dust and debris. The following irregularities include the omission of some sections:

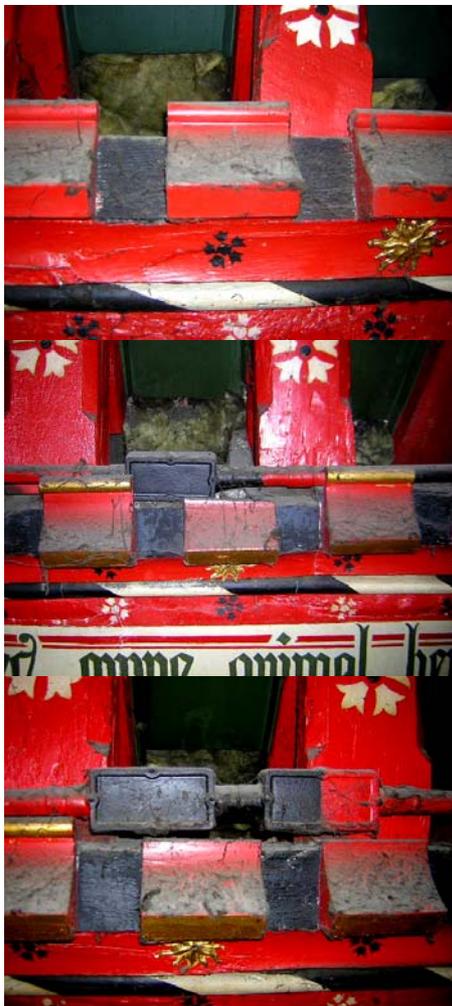
**Figure 3** - The East wall, between trusses 2 and 3, the upper part of the castellation has not been gilded.

- There was a row of these brackets that had not been gilded. These were given a coating of oil size and were gilded using 23½ carat gold leaf.
- After removal of an old conduit, there were a number of crenallated brackets that needed to be built up by the in-house carpenter. The new wood was painted with

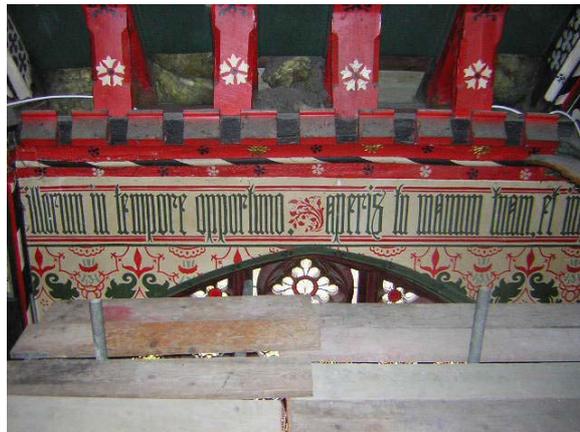
**Figures 6** – A broader view of the inscription

A Latin inscription runs below the ceiling along the east and west walls. It consists of dark green lettering on a cream background with a red border and decorative infills. The paint is applied to a plaster substrate. The description reads:

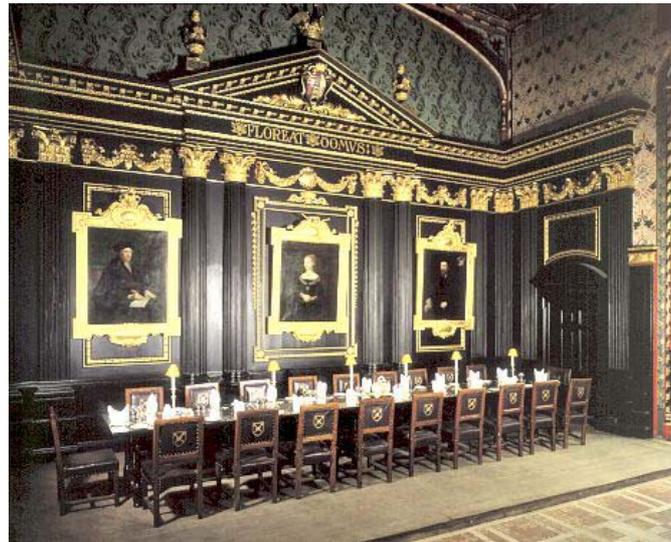
**Figure 7:** The Gilded panels on the South wall.

Generally the panelling is sound although this is beyond the scope of this report. The gilding, however, appears dull. Whilst there will inevitably be some loss of lustre through ageing of the leaf, the quality of the gilding may also have affected its appearance.

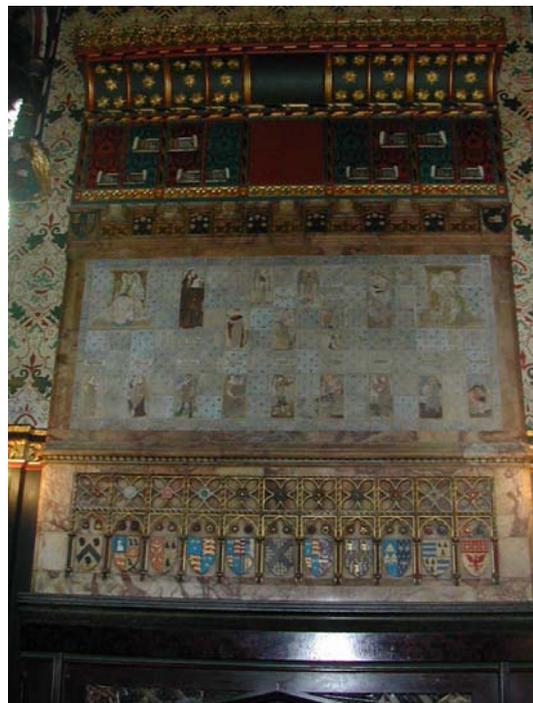
**Figure 8:** The upper portion of the chimneypiece before restoration.

Numerous elements of original polychrome on the alabaster, in the form of shields and rosettes above the over-mantel, have been over painted. However, where the original still exists, the quality is found to be in extremely good condition **(see appendix 1, photograph 19)**.

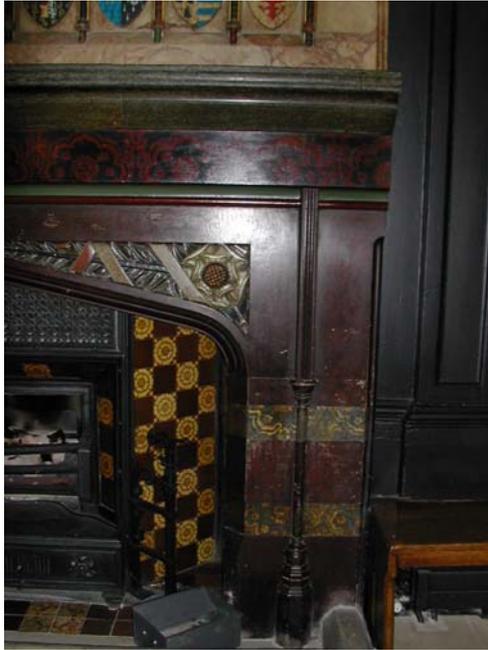
**Figure 9** – The hearth before conservation. Note the heavy discolouration and the over-painted strip beneath the purple marble mantel.

The hearth is in poor condition, having been heavily abraded during use. Furthermore its appearance has become even more unsightly due to the thick coating of varnish that has discoloured significantly. In conjunction with this is a layer of dirt, slightly oily in nature, that is probably a combination of smoke from the fire and nicotine staining, causing the pattern beneath to be barely apparent. Possibly as a result of this, and in an attempt to revive it, the strip immediately below the mantel has been over-painted with colours that differ to the original (see **figure 9**), causing an unbalanced appearance.

- Discoloured varnish was removed with a combination of ammonium hydroxide solution (pH10) followed by acetone.

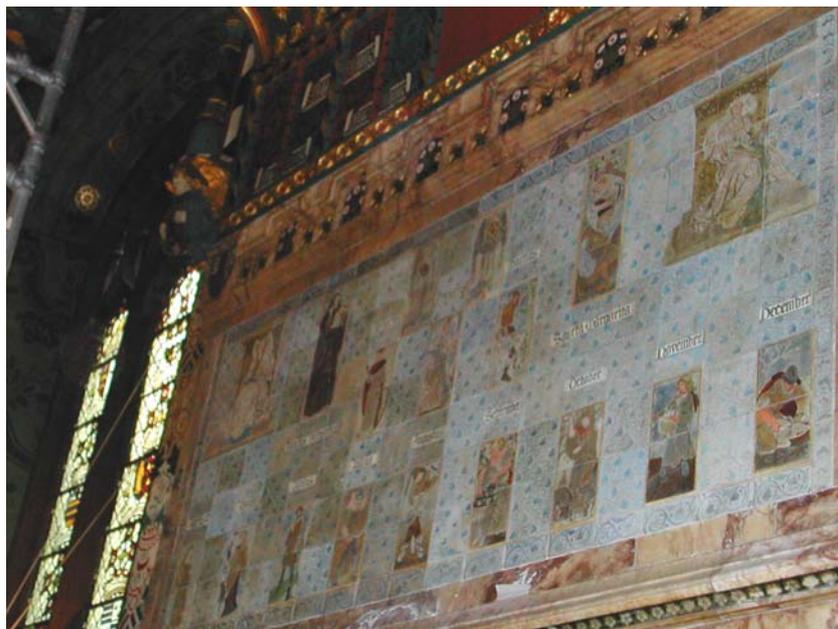
**Figures 10**– Figure 10 shows some the tiles during cleaning. The right side having been cleaned is visibly brighter, the left side is starting to be cleaned.

- Yellow staining was reduced on the tiles using a solution of hydrogen peroxide (3% in de-ionised water).
- The tiles were poulticed with blotting paper soaked with hydrogen peroxide (3%), sprayed with dilute ammonium hydroxide solution (pH10), before being covered with Melinex and left for a number of hours. This process was repeated as necessary until an even clean was achieved.

- Discoloured overpaint was removed using scalpel blades, leaving behind red staining (see figure 10).

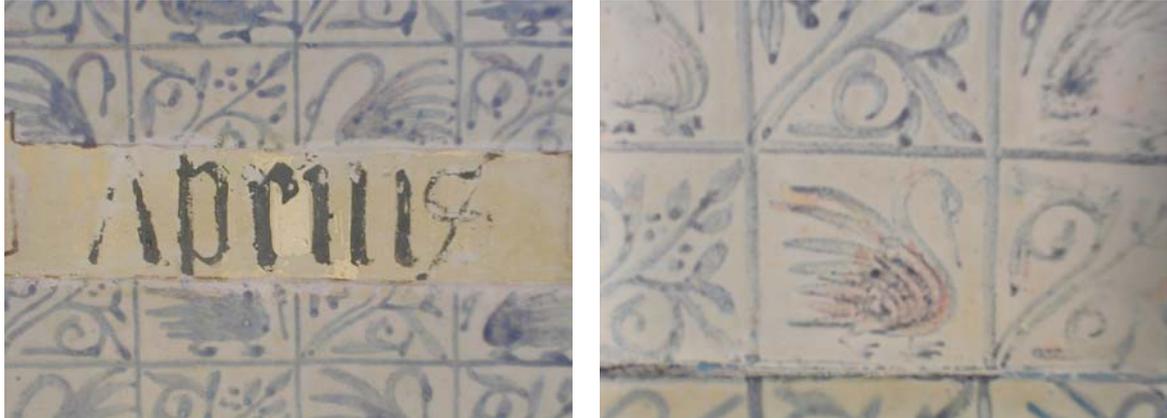
Much of the deterioration of the tiles is related to the failure of glazes, which have become porous, allowing them to take on pollution and staining. This has previously given rise to over-painting, which appears to have been clumsily undertaken, leading to loss of definition and detail **(see appendix 1, photographs 20, 21)**. The current appearance of the tiles allows little distinction between the ceramic tiles and alabaster.

**Figures 11 and 12** – Figure 11 (left) shows an example of the flaking over-paint.  
Figure 12 (right) an example of the staining after the removal of the over paint.

- The tiles were then retouched using dry pigments bound in Paraloid B-72 in xylene.

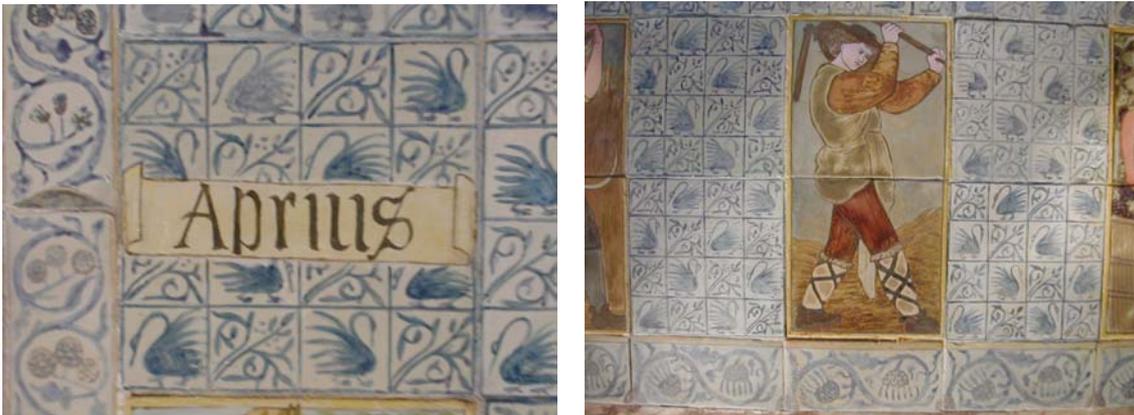
**Figures 13 and 14** – Figure 13 (left) shows the tile shown in figure 11 after retouching.  
Figure 14 shows a larger section of the tiled area after cleaning and retouching.

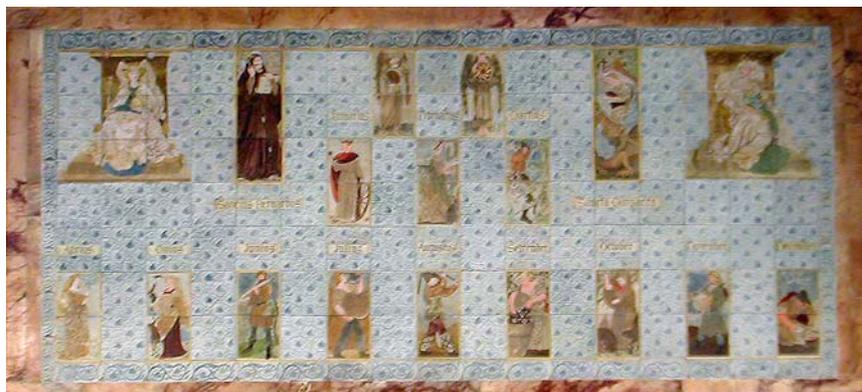
**Figure 15** – An overview of the tiles after cleaning and retouching.

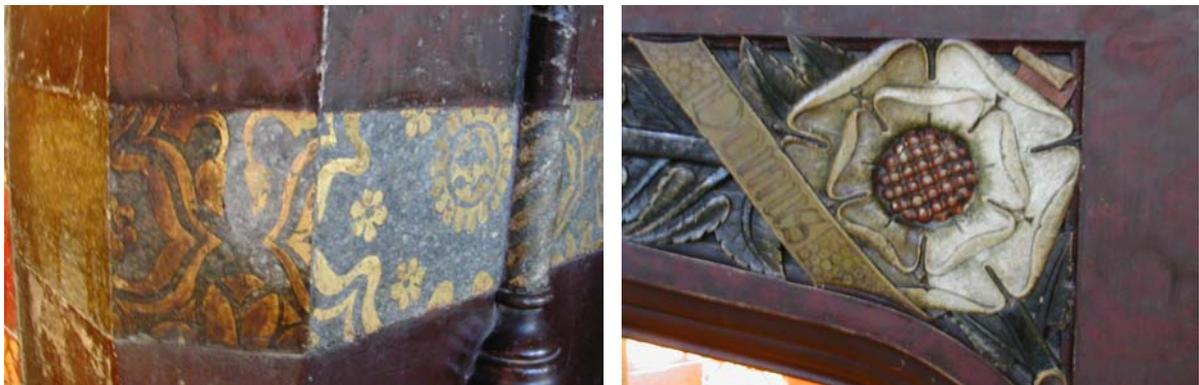
**Figure 16 and 17** – During the removal of the varnish from the hearth, and during cleaning of the rose motif.

- Overpaint was removed with ammonium hydroxide solution (pH10) to reveal the intact original scheme.
- Overpaint was also removed from the moulding beneath the over-mantel to reveal two different patterns not repeated in the overpaint.

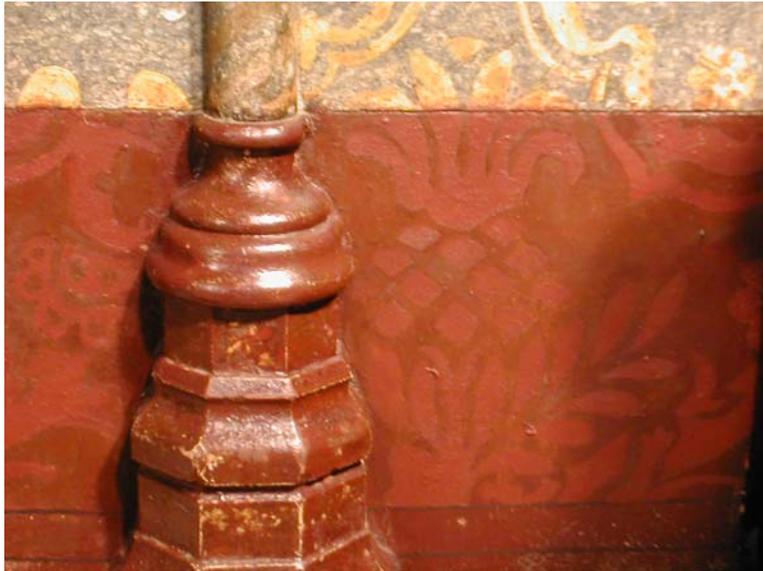
**Figure 18** – Reinstating the design with stencilling.

- An isolating varnish of Paraloid B-72 (8%) in xylene was applied to the fireplace.
- The darker background colour was retouched using dry pigment and Paraloid B-72 (8%) in xylene and the paler colour in acrylics. The lower right area of the hearth was extremely badly damaged and it was therefore necessary to cut a stencil using thick acetate to reconstruct the design. Using this stencil the paler colour was stippled onto the darker colour (see **figure 18**).

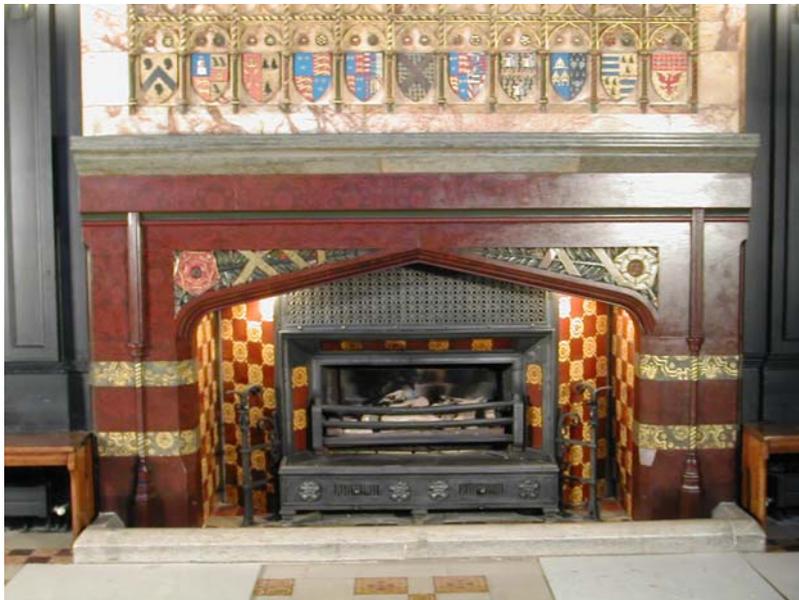
**Figure 19** – The hearth after cleaning, varnishing, retouching and application of final varnish.

- The gilded purbic marble detail was retouched using Paraloid B-72 (8%) in xylene and Mica.
- The fire surround was then given a final coating of matt varnish (20% MS2A in white spirit with the addition of a small amount of microcrystalline wax) to protect.

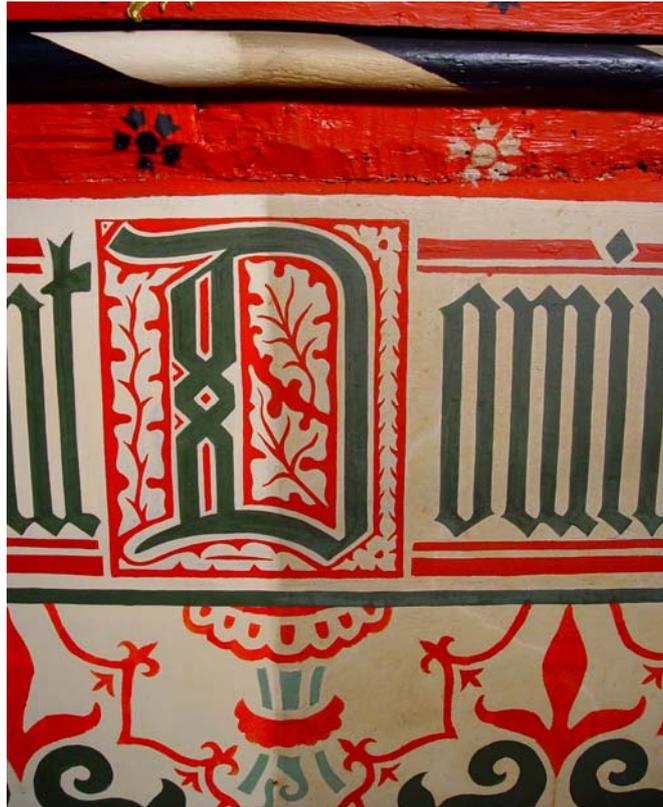
**Figure 20** – A detail of the wall during cleaning. The left side has been cleaned.

- The walls were cleaned using a dilute ammonium hydroxide solution (pH10).

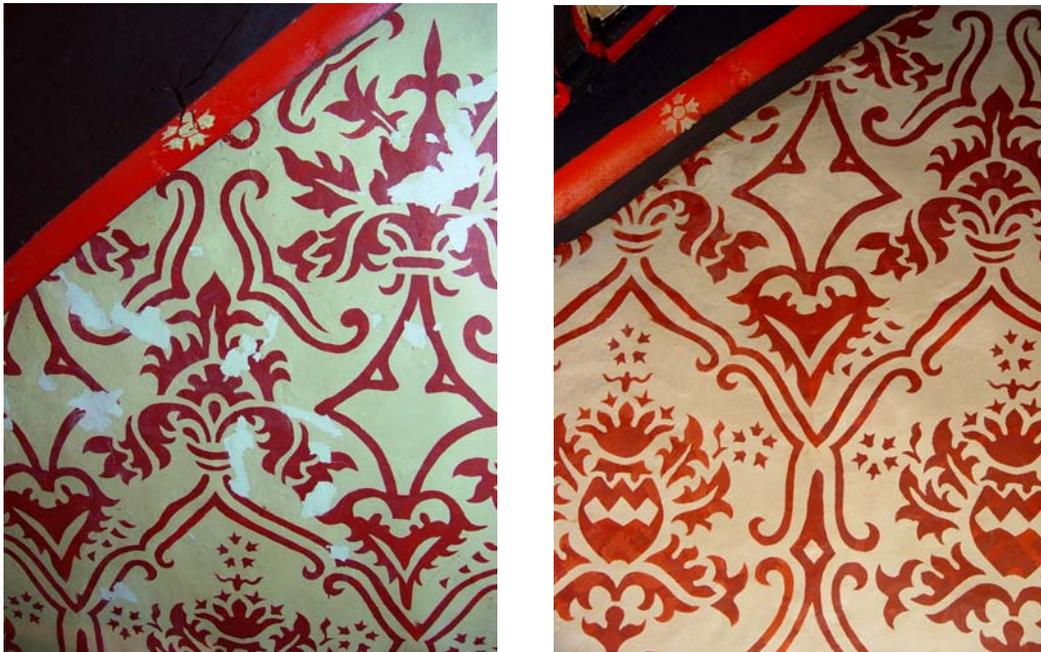
**Figures 21 and 22** - show a section of the upper wall on the south wall after filling but before (left) and after (right) retouching.

- An area of damaged plaster to the right of the doorway in the gallery (old doorway) was secured and pinned. Areas of loss were filled with fine putty comprising Mowiol 4-98 and whiting, when dry this was levelled. The walls were retouched using acrylics.
- Areas of severe flaking were consolidated using Plextol B500 diluted with water (10%). This adhesive solution, with the addition of IMS to reduce the surface tension, was also injected into areas of blind cleavage using a hypodermic syringe. Blisters and flakes were laid flat using a hot spatula set to 75°C. Some particularly unstable areas of the wall, blown due to soluble salt efflorescence, were scraped back. All areas of loss were then filled using a Mowiol 4-98 and whiting putty, which was levelled when dry (see figure 22).

- All losses to the walls were retouched using acrylic paint (see figures 21 and 22 for examples).

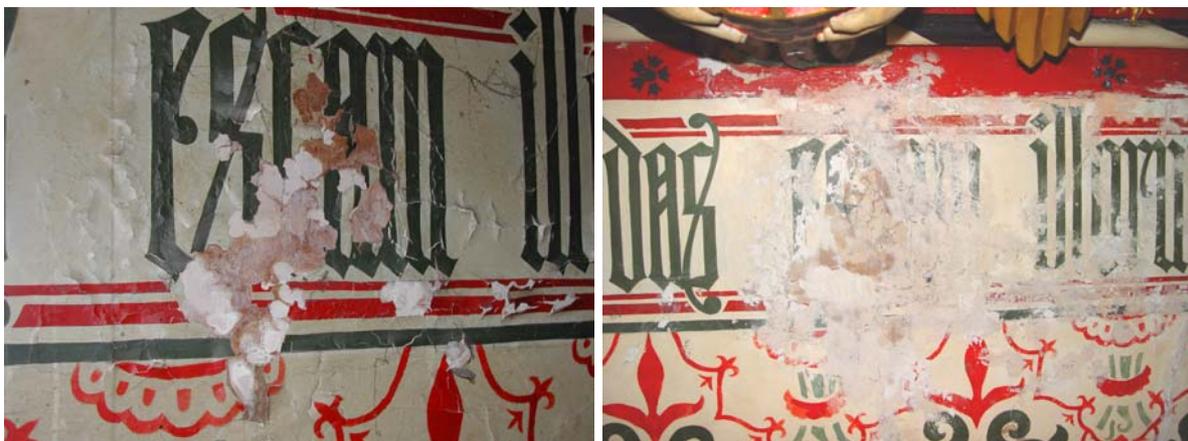
Little failure was noted, with the exception of the painted inscription above the oriel window where the failure is extreme and across most of the inscription surface with a small area of failure above the panelling. Both of these areas may relate to external factors; the former may have occurred as a result of the movement of moisture from the roof of the oriel window through the wall, and the latter may be related to an early window that was later in-filled by brick courses. Assessment with the capacitance metre indicated that moisture content was high in these areas. In addition, the failure above the panelling may have been exacerbated by heat emissions from lighting positioned at this height.

**Figures 23 and 24** - The area of inscription that was badly damaged before treatment (left) and after consolidation and filling (right).

- Part of the Latin inscription that runs around the top of the walls was badly damaged as a result of soluble salts. The large losses were filled with a whiting and Mowiol 4-98 putty, which was levelled when dry. The design was reconstructed using a stencil made from surviving lettering. This was then retouched with acrylic paints (see figures 23-26).

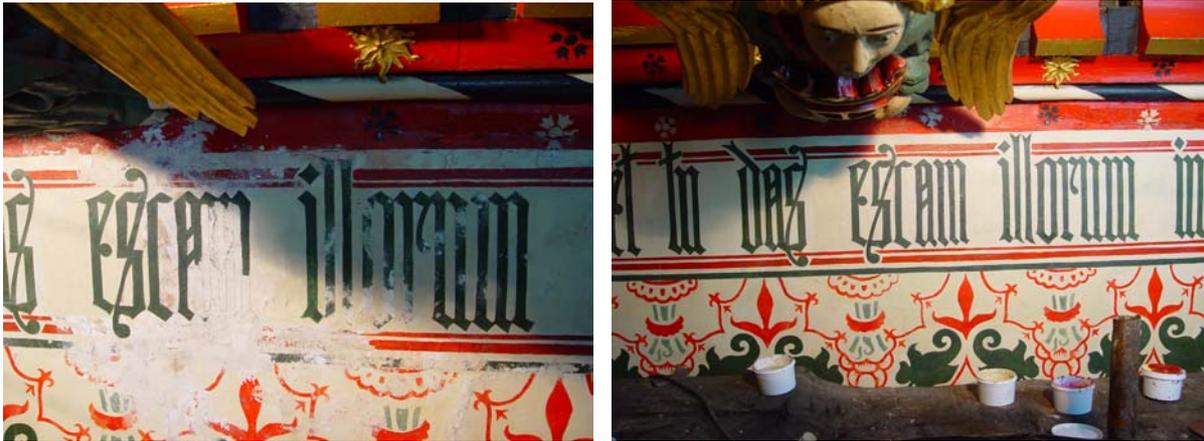
**Figures 25 and 26** – The area of inscription that was badly damaged during (left) and after reconstruction (right).

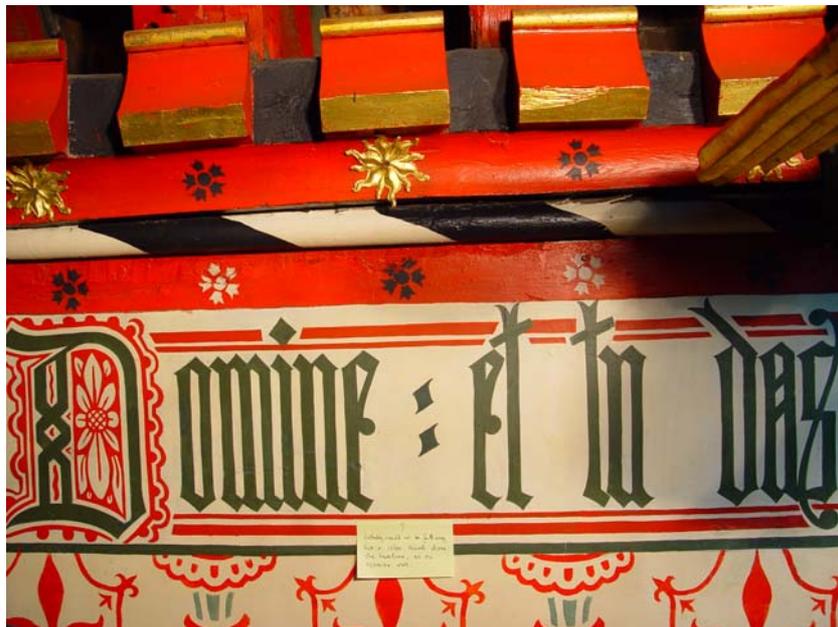
**Figure 27** – A section of the inscription after being corrected.

- There were three parts of this Latin inscription that had been painted incorrectly during one of the previous restoration schemes (two full stops should have been colons, and Dominn should have read Domine). These inaccuracies in the inscription were corrected using acrylic paints as requested by the client (see figure 27).

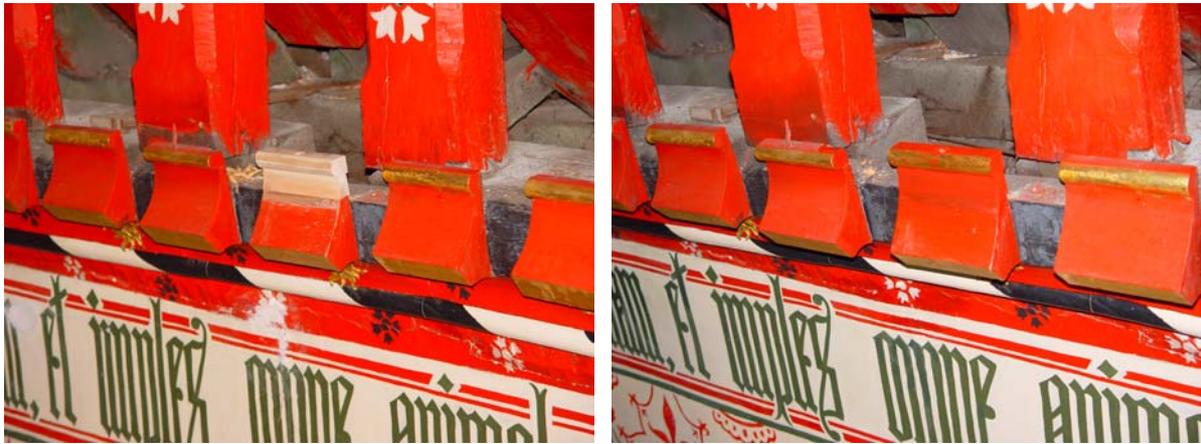
**Figures 28 and 29** – One of the partially damaged crenellated brackets during repair, and after redecoration.

red acrylic paint, coated with 3-hour oil size, and then gilded using 23½ carat gold leaf.

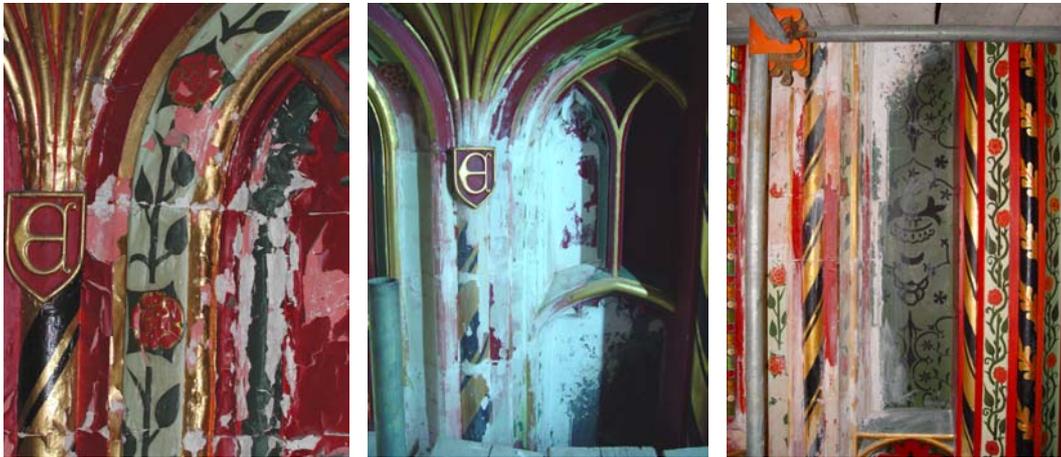
The decoration in the oriel window has been severely effected by moisture ingress and salt efflorescence. This failure, on the south face of the window, is extreme and has resulted in the loss of much of the painted decoration. Assessment with the capacitance metre revealed extremely high moisture content. **(see appendix 1, photographs 17, 18).**

**Figures 30-32** – Figure 30 shows part of the Oriel before treatment, 31 and 32 after filling and sanding.

- All areas of blown stone and plaster, damaged as a result of soluble salts, were scraped back and filled with fine surface Polyfilla. These areas were then sanded (see figures 30, 31 and 32).

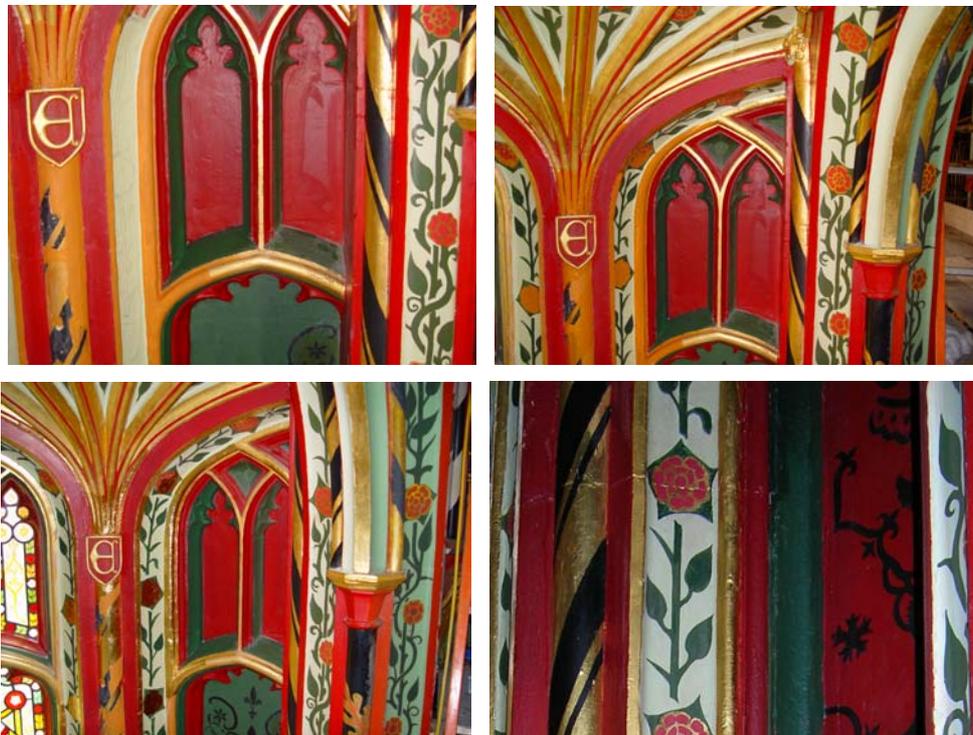
**Figures 33-36** – Figures 33-35 show the reconstruction of the damaged Oriel window involved copying existing design and extending it. Figure 36 shows a particularly damaged area of the Oriel window after restoration.

- The extensive areas of damage to the decorative scheme were reconstructed using acrylic paints and gold leaf (see figures 33-36).

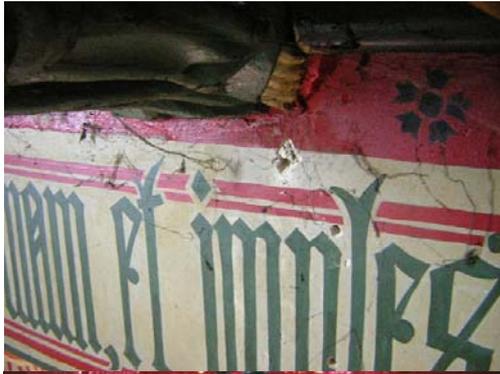
The frieze is in generally sound condition but has areas of delaminating and lost paint (**see appendix 1, photographs 1-5**).

**Photograph 1** - Frieze below Angel 2 showing holes in the paint and plaster that may have contained fixtures. The plaster substrate is crumbling slightly.

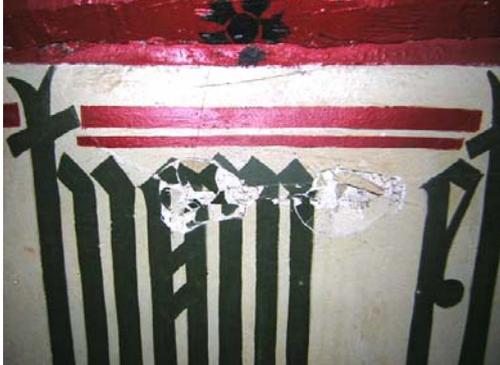
**Photograph 2** - Right, between trusses 3 and 4, two holes of crushed paint and plaster, likely to have been caused by scaffold poles.

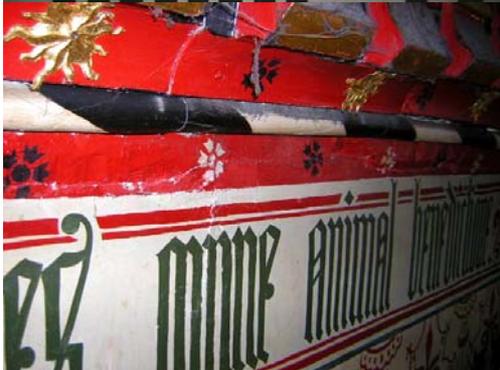
**Photograph 3** - Right, between trusses 3 and 4, unevenness in the red band and some moderate flaking. Worm flight holes in this section have paint over them confirming that the worms are no longer active

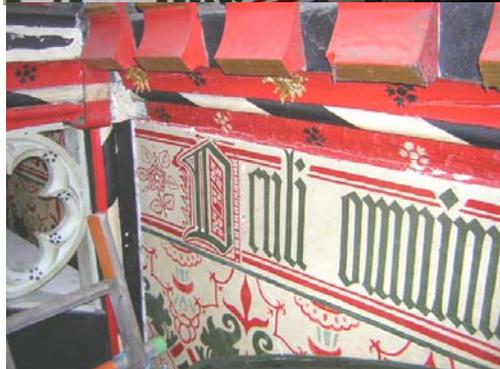
**Photograph 4** - Right, truss 4, flaking in the red border

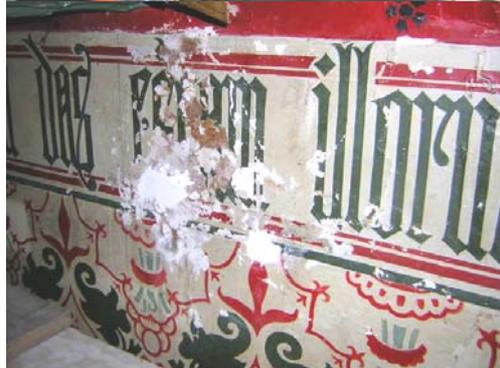
**Photograph 5** - Area of damage on wall beneath corbel on the west wall caused by water ingress.

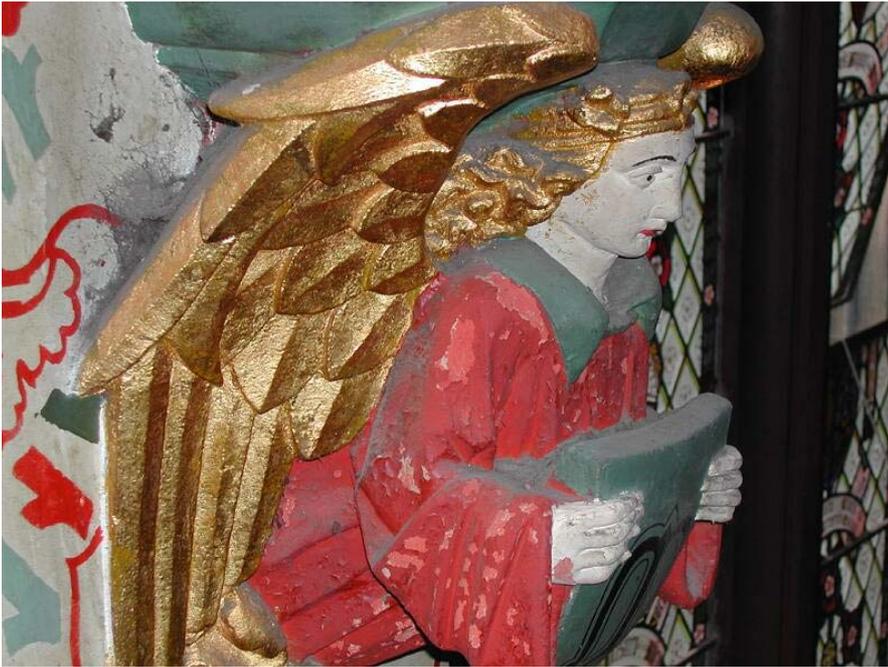
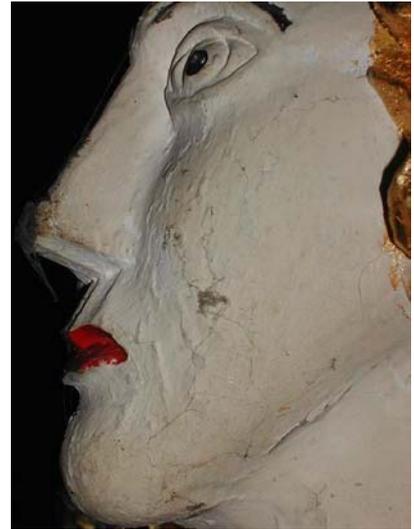
The corbels were generally found to be in good condition, although failure of the painted decoration was extreme on each of them, manifesting itself as lifting and delamination of macro flakes of paint (**see appendix 1, photograph 6**).

The surface of the paint was covered with a layer of particulate dust and dirt. In addition, nicotine staining and other imbibed deposits were apparent on the paler colours of decoration.

**Photograph 6** - failing paint on corbels. Note also thick dirt on upper surfaces

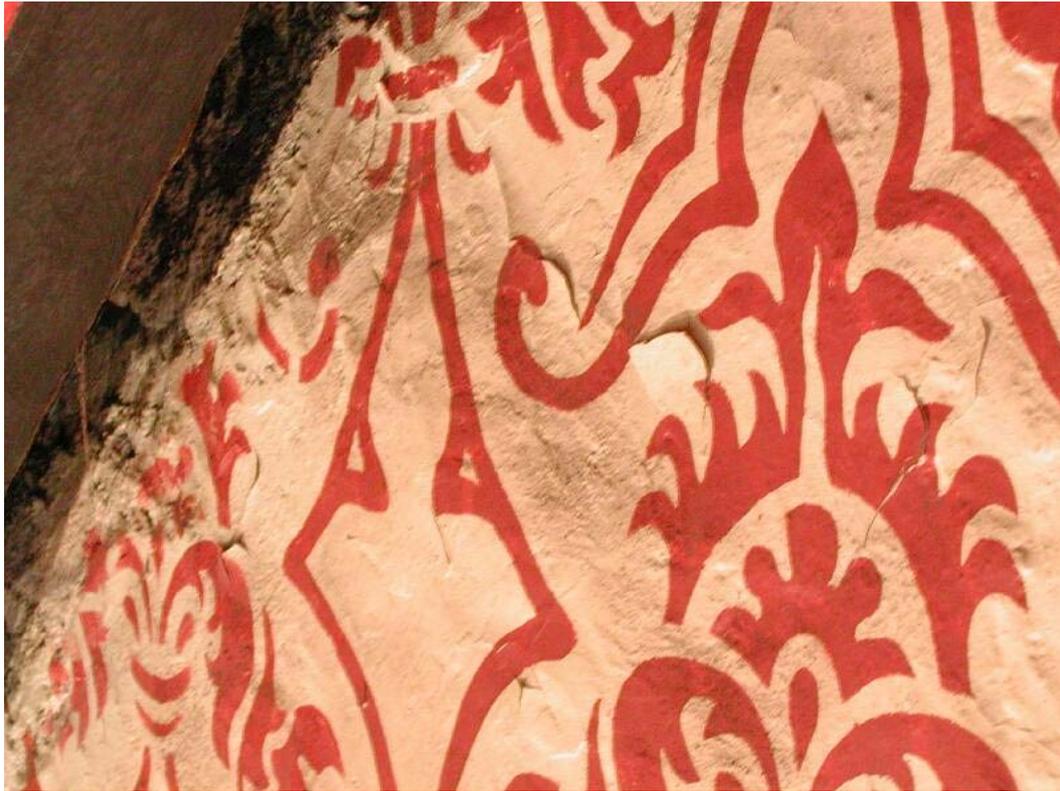
Investigation of this area identified macro flaking, each area being between 10 and 20 cm<sup>2</sup>, and with approximately four or five of these areas per square metre (**see appendix 1, photograph 8**). The plaster was also found to be hollow in areas, although it appears stable at present. The paint film is discoloured by heavy surface dirt and nicotine staining. More problematic to the cleaning process is the manner in which the painting has been executed; the pattern has also been part hand painted, which became more obvious on cleaning. From the ground, however, this difference is less noticeable.

Assessment of this area by capacitance metre did not indicate any areas of high moisture content suggesting failure may be linked to environmental conditions and failure at the interface between incompatible paint films.

**Photograph 8** – upper wall area, flaking and delamination of paint.

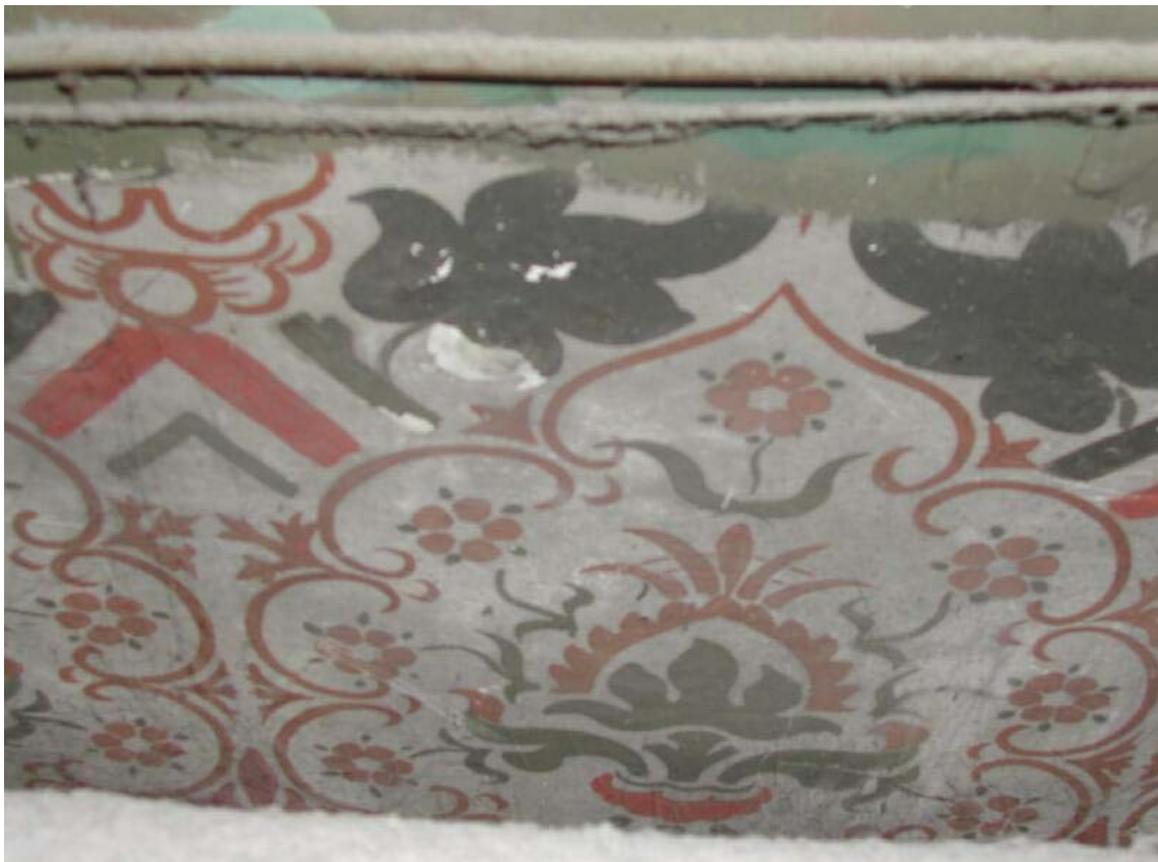
**Photograph 9** – main wall area, original paint behind over-mantel.

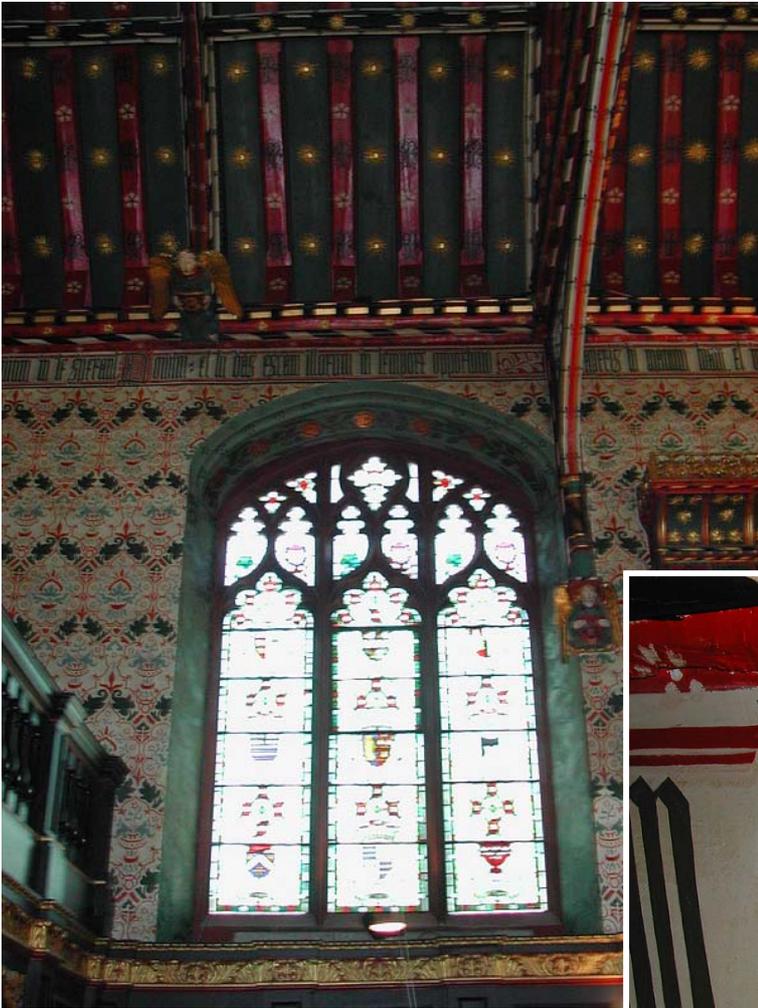
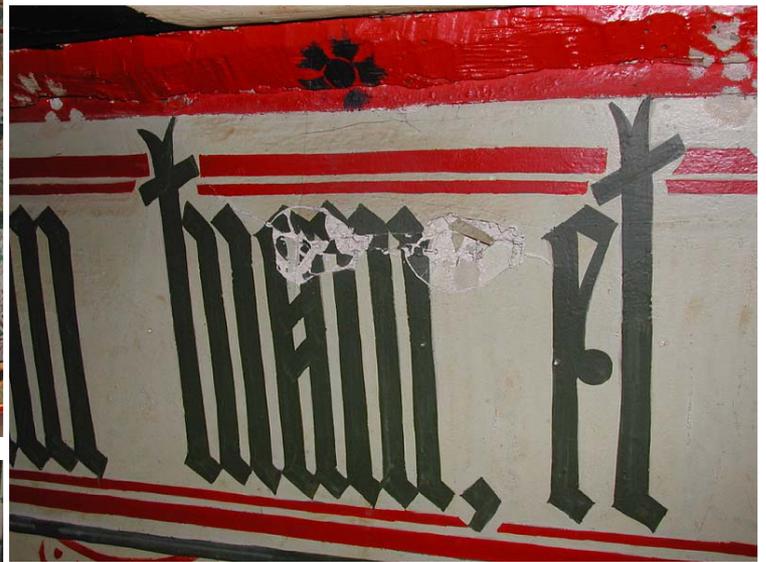
**Photograph 10** – East elevation main wall area, south end

Area of failure

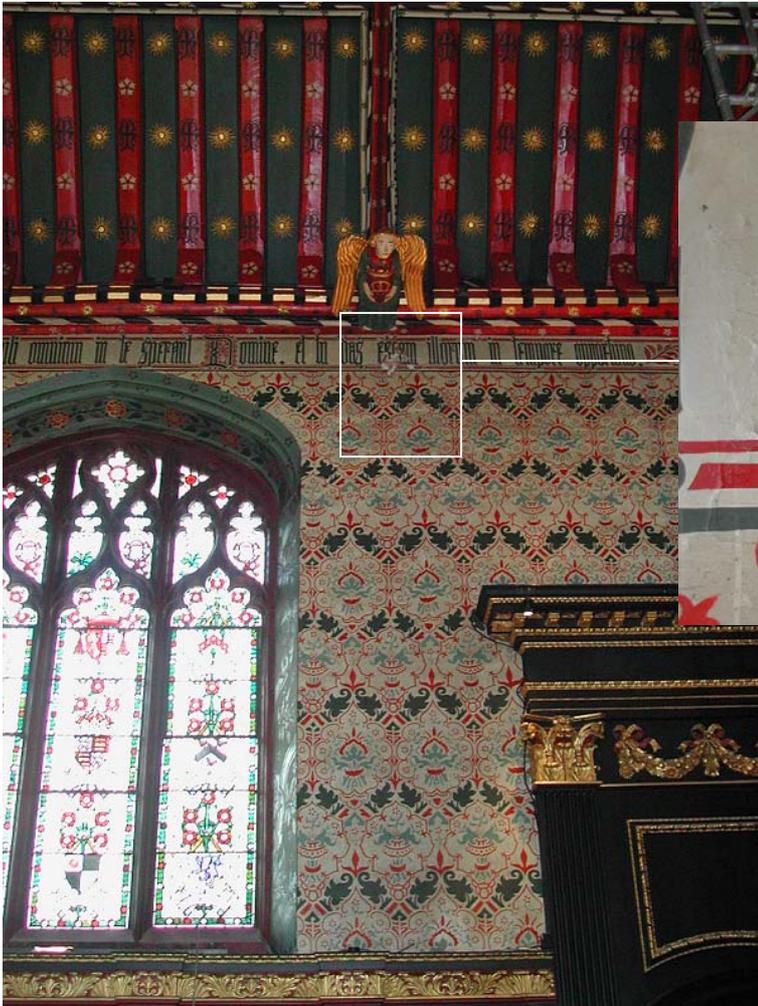
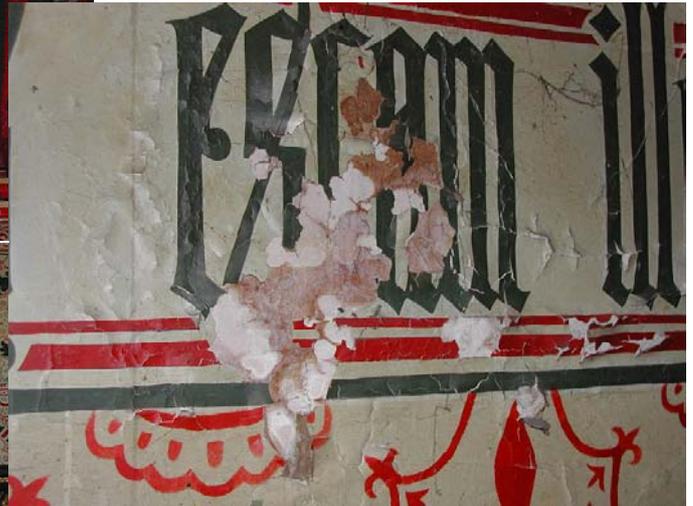
**Photograph 12** – East elevation main wall area north end

Area of failure related to water ingress

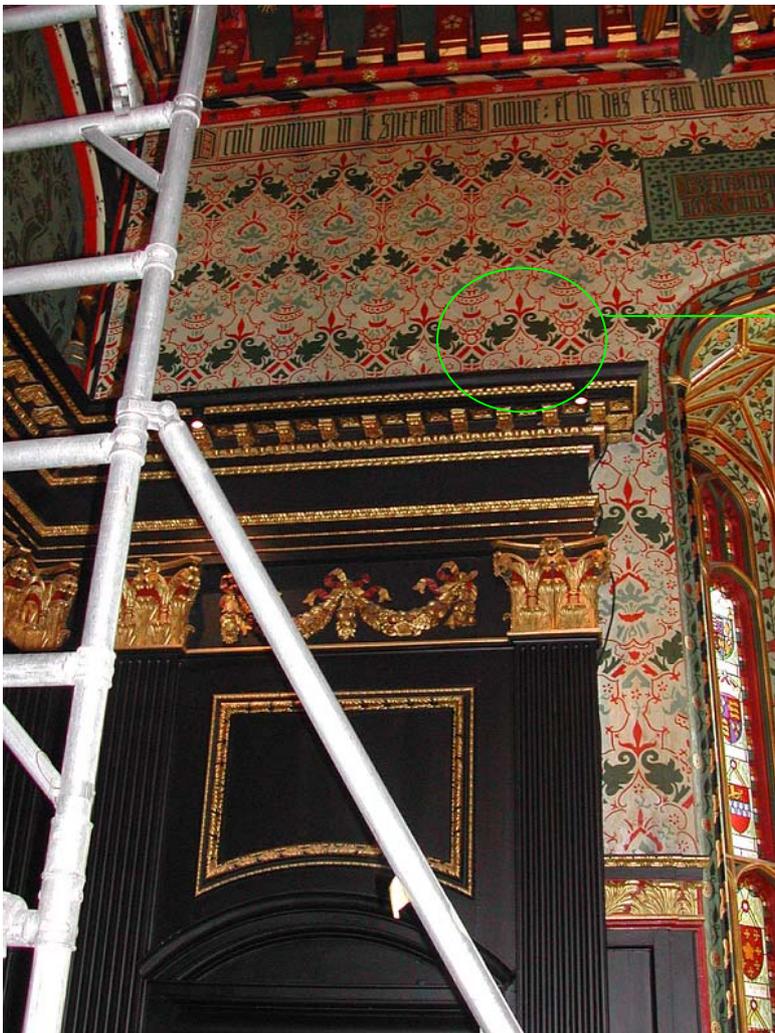
**Photograph 13** – mid wall area, east wall, north end

Area of failure

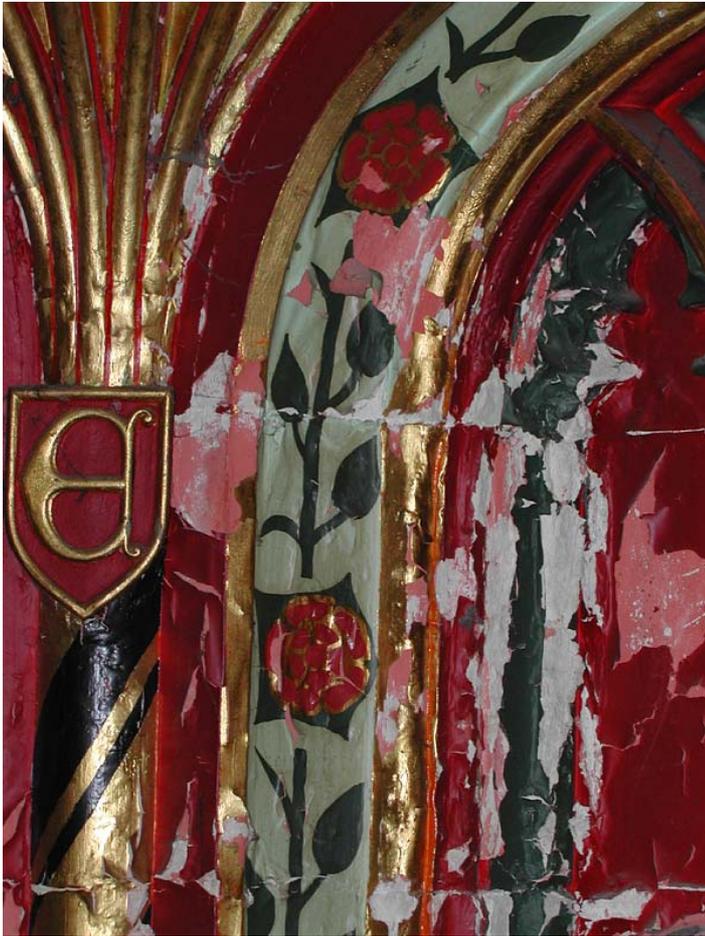
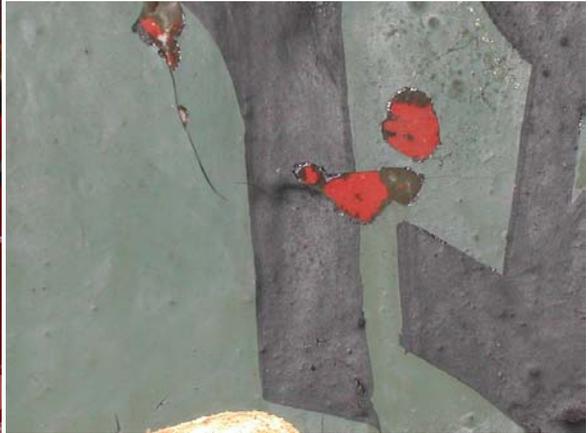
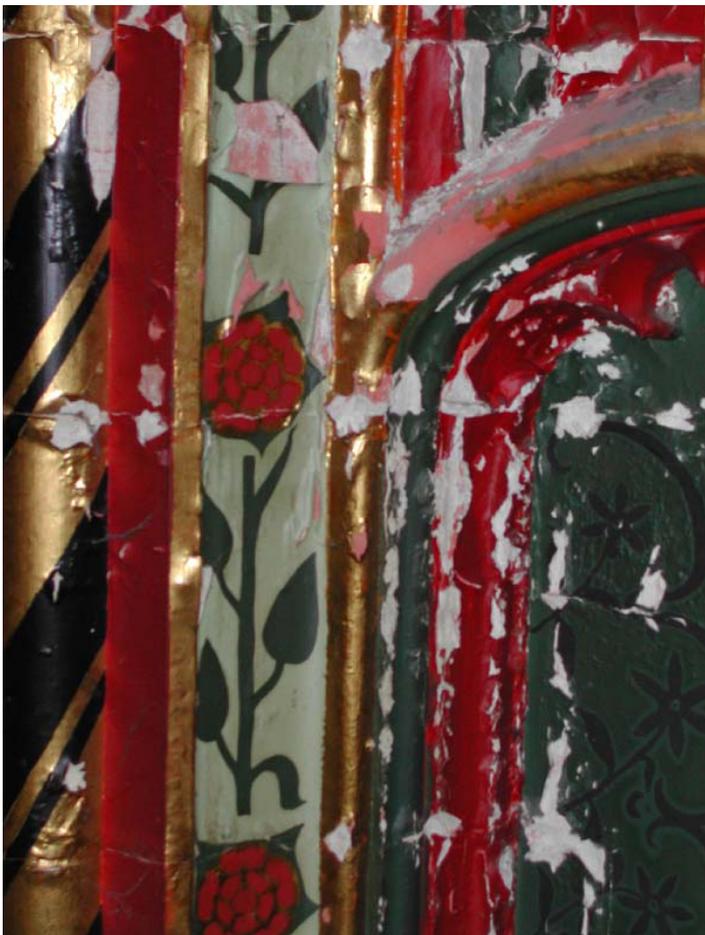
**Photographs 17 and 18:** Oriel window, failure of paint film due to water ingress.

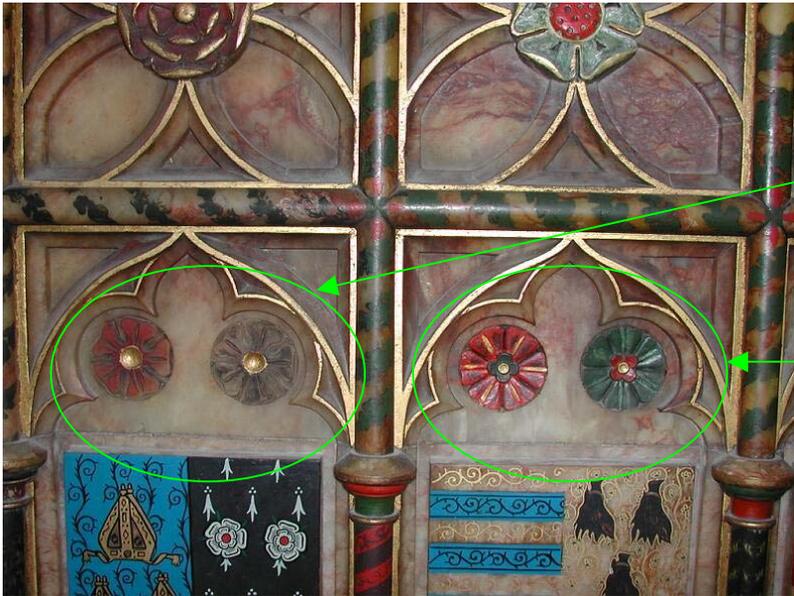
**Photograph 19** - detail of chimney piece

Original polychrome

Overpaint.
