**Condition Assessment  
and Treatment Report for  
The Old Hall,  
Queens' College,  
Cambridge.**

**January-May 2005**

**Project:** Cleaning and restoration of the fireplace and polychrome decoration in the Old Hall, Queen's college, Cambridge.

**Nature of project:** Condition survey of the polychrome decoration on the ceiling and walls.

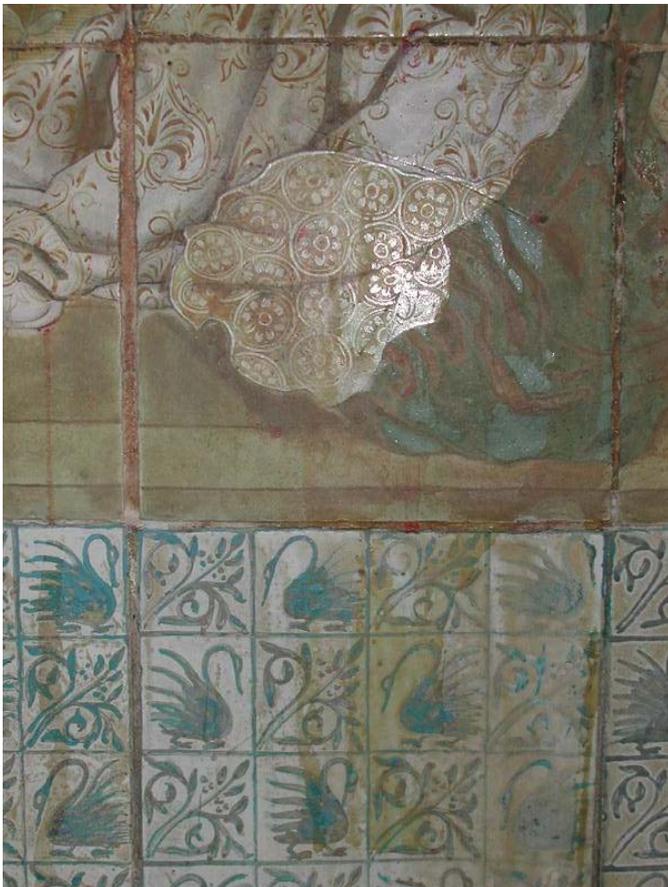
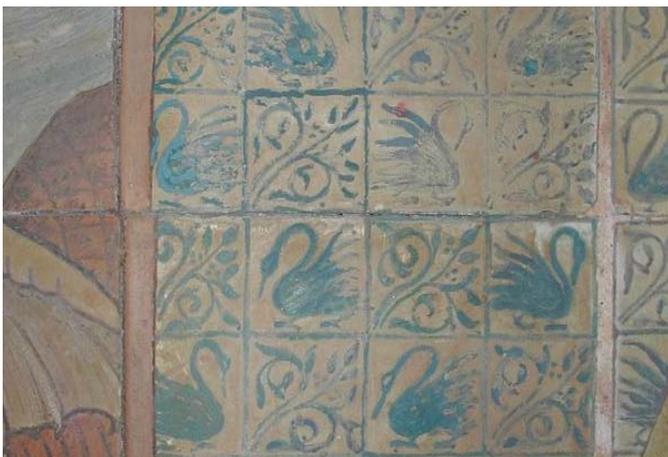
Much of the deterioration of the tiles is related to the failure of glazes, which have become porous, allowing them to take on pollution and staining. This has previously given rise to over-painting, which appears to have been clumsily undertaken, leading to loss of definition and detail **(see appendix 1, photographs 20, 21)**. The current appearance of the tiles allows little distinction between the ceramic tiles and alabaster.

**Photograph 20, 21** - detail of painted tiles of chimney piece, illustrating surface soiling and staining of the ceramic body.

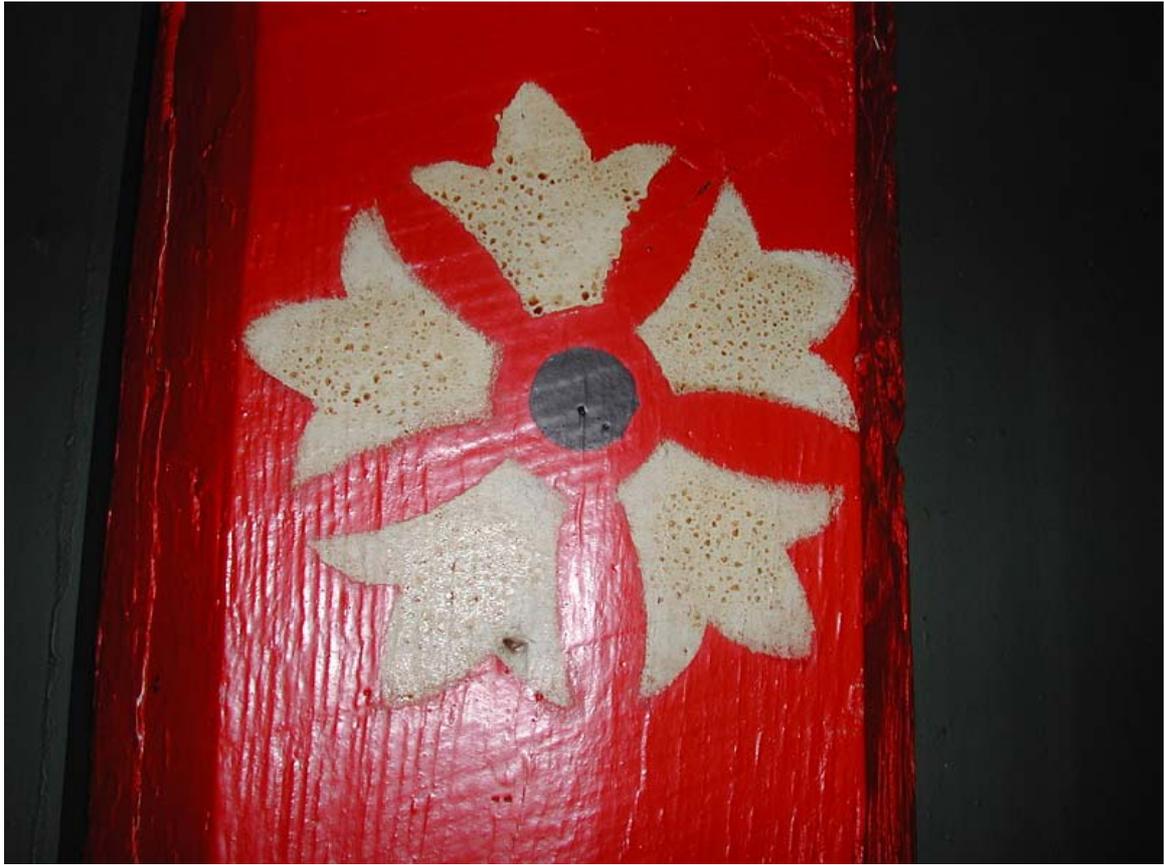
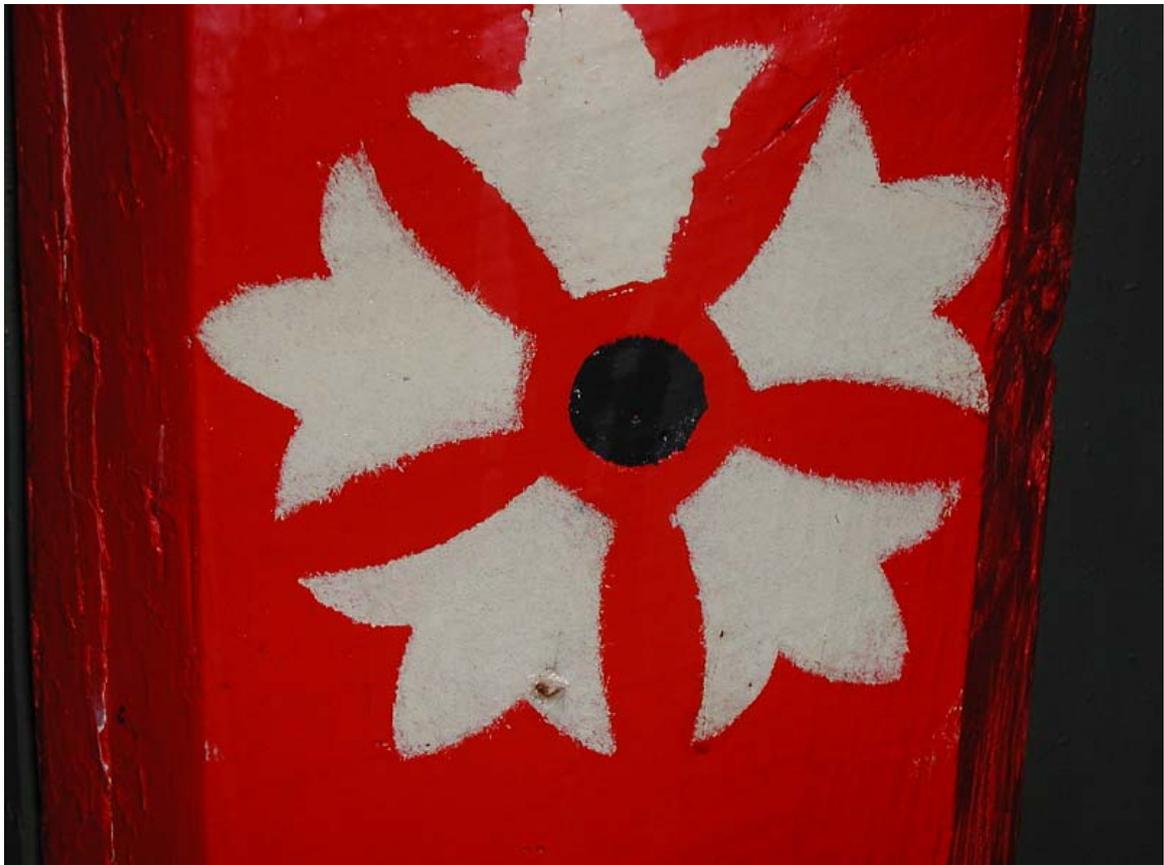
**Photograph 22 (top) and 23 (above)** - before and after cleaning

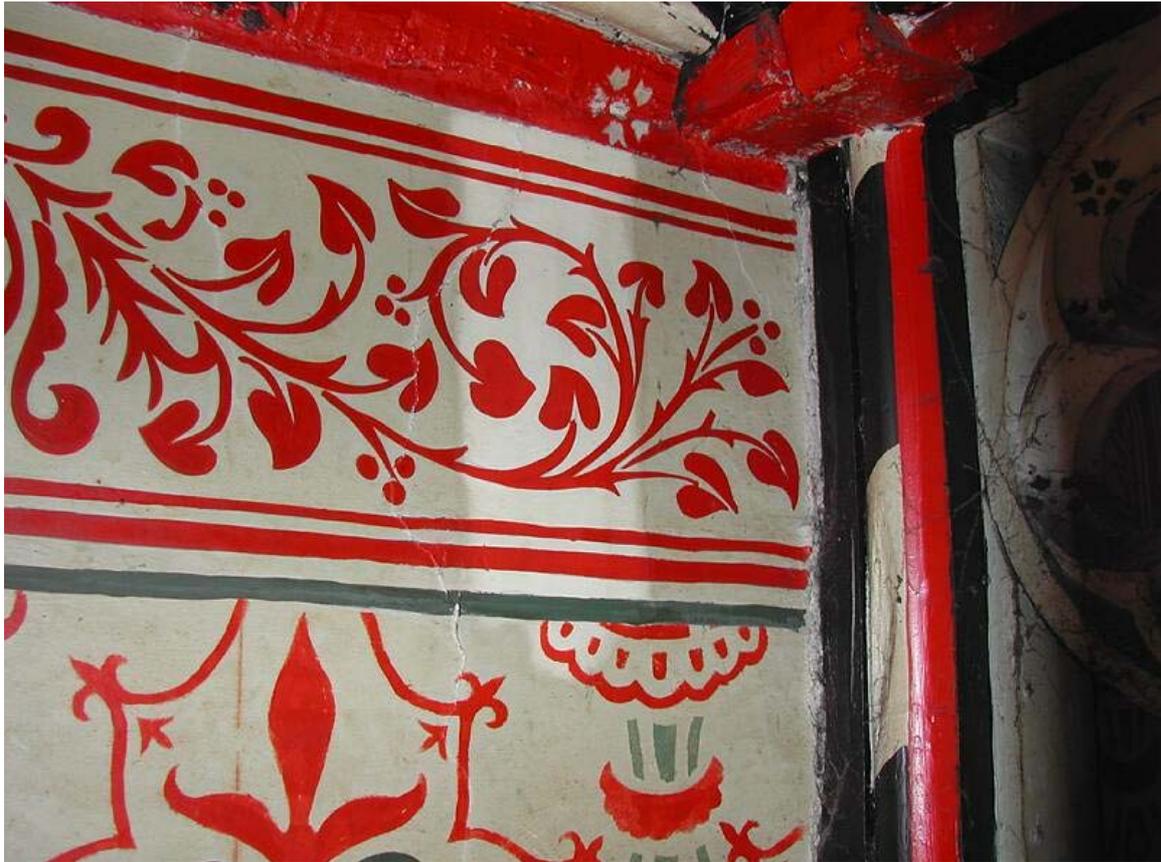
The use of ammonia solution proved effective in reducing surface staining (see appendix 1).

**Photograph 24** – mid wall area above chimneypiece, illustrating the results of cleaning tests using dilute ammonia solution.
